## HUMC's Stained Glass Windows

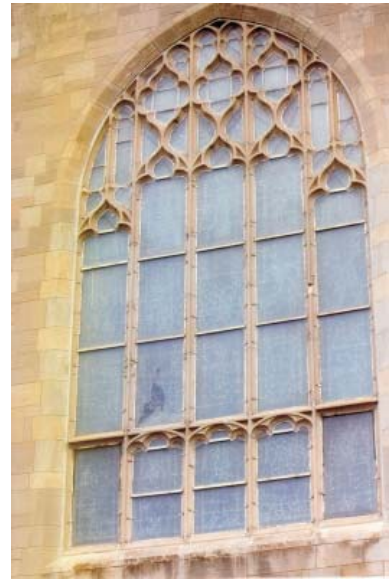
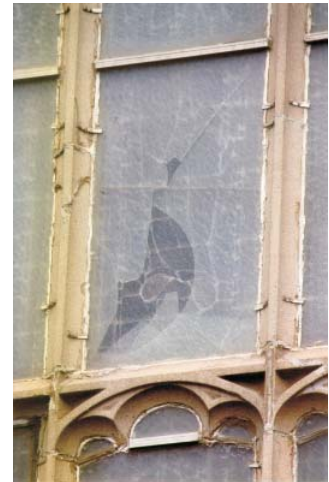
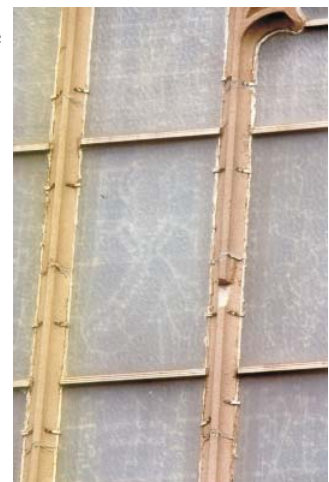
If everything goes according to plan as this is being written in mid-July, anyone who has attended services the past couple of weeks has noticed the work being done to protect the large stained glass window in the chancel area, one of many signature works of art in our building. Earlier this summer the trustees concluded that the many issues surrounding the windows needed attention. The problems have built up over the years due to a variety of issues, the primary ones being moisture leakage because of worn caulk and heat buildup. The Trustees voted to proceed with immediate repair and protection of the chancel window because of the severity of its condition. The pictures here illustrate some of the problems with this window.

Two major problems led to the decision to take immediate steps with this window. First, a large pane of glass in the layer protecting the stained glass exploded due to heat buildup, putting the stained glass itself in jeopardy. Moisture was also coming in due to the missing and worn caulk around the window. Moisture has an adverse affect on the leading and frames for the stained glass and on the performance of the organ, another landmark of the Hamline United Methodist Church.

The cost of this one project is in the range of \$45,000, with approximately half that expense for tuck pointing and repair of the stonework surrounding the stained glass. While, as with the roof replacement last year, this is not an insignificant sum of money, the windows, in total, are valued in the millions of dollars. They are the building's greatest asset, as has been noted by many people numerous times over the decades.

The current plan is to restore other windows as funding and fund raising permits. The upper windows on the west side of the building are leaking, too, and will need restoration as soon as possible. The entire project will: A) protect the irreplaceable windows, B) enhance the vividness of the colors, and C) continue the effort to seal the interior of the building from water and moisture damage. Specific donations in support of window restoration should be marked for that purpose and would be welcomed as soon as you are able.
